Tine Frøysaker,  
Mirjam Liu  
and Thierry Ford

## Backing Munch – past and recent attachment of Edvard Munch’s monumental Aula paintings to rigid supports

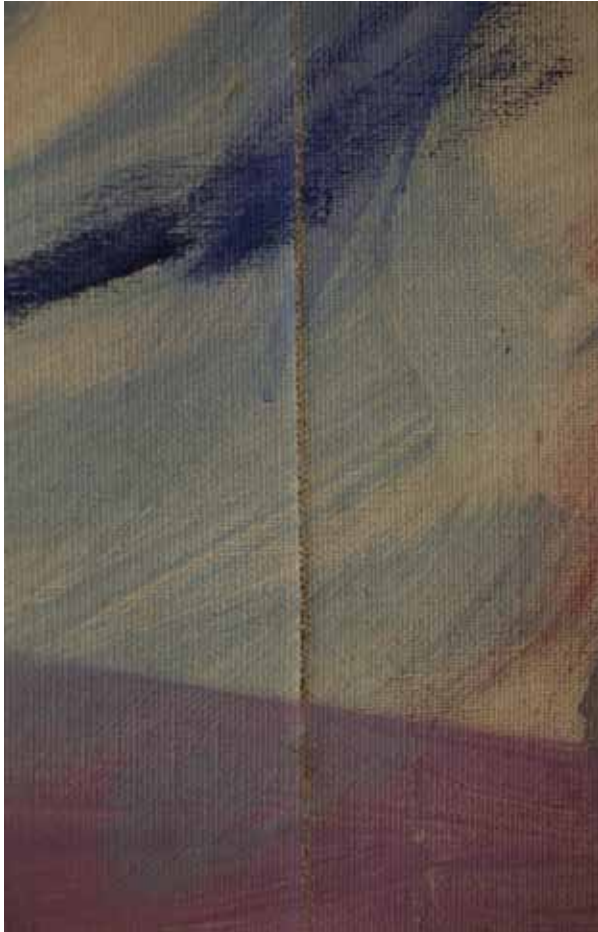
1 Detail of *Men Reaching towards the Light* showing a typical tear and bulk in the canvas, flaking paint and a number of paint losses. These were caused by movements in the wooden framework behind the masonite from 1946. Photographer: Mirjam Liu, January 2011.

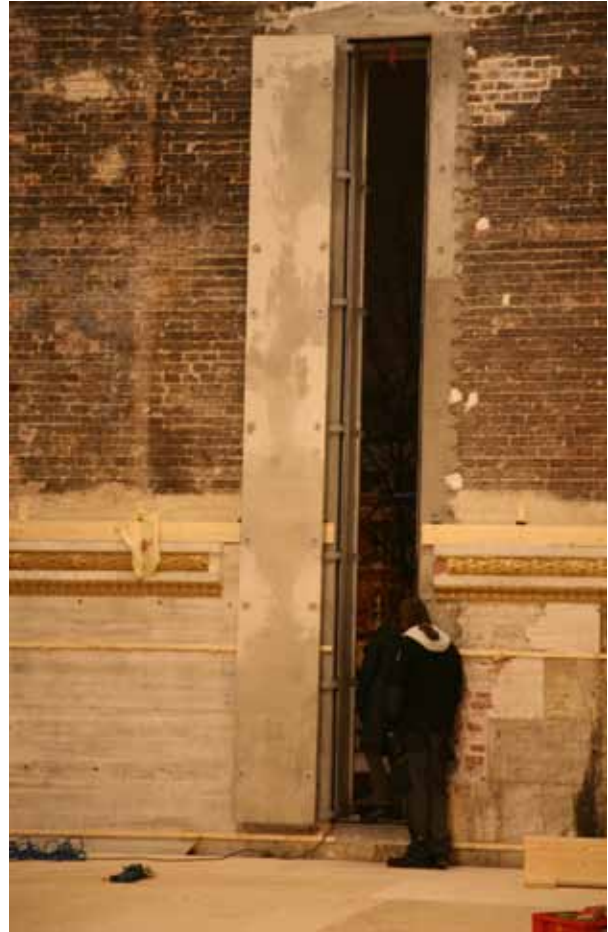
2 The new door (5,6 x 0,55 m) during opening at night. Photographer: Karen Mengshoel, March 2011.

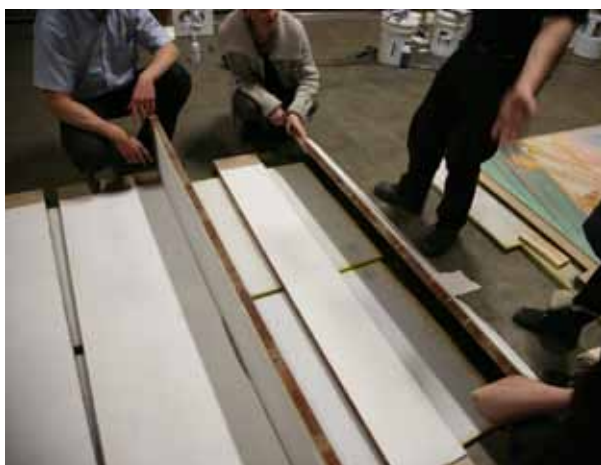
3 Visual examination of the test panel with a double marouflage after being cut. Photographer: Karen Mengshoel, April 2010.

prepared, and the new marouflage materials attached to the reverse (see also paragraph 4). After curing, the test panel was then cut in to several pieces so that the efficiency of the bonding between the masonite and honeycomb could be assessed (figure 3). The immediate results showed that the marouflage process of the test panel was unsuccessful with large areas of visible delamination between the two materials. The reason for this was not due to the materials or process but rather caused by an uneven floor. Since both the foam sheets and the masonite are malleable materials they formed closely to the contours of the uneven floor in contrast to the stiff and level nature of the honeycomb panels. This meant that either, a greater amount of pressure was necessary in order to counteract the uneven nature floor or, that the working floor itself had to be leveled out. It was considered unsuitable to exert more pressure since this would put the original paintings under an unacceptable amount of stress and the working floor had thus to be leveled as evenly as possible. In addition, the slight gap filling ability of the adhesive, required the new leveled floor to ideally have no more than 1 mm deviation per meter. This is a standard that was difficult to obtain since the highest class of Norwegian floor leveling is less even than this, but a definite re-leveling was necessary before the working floor was acceptable for the proposed treatment.<sup>31</sup>

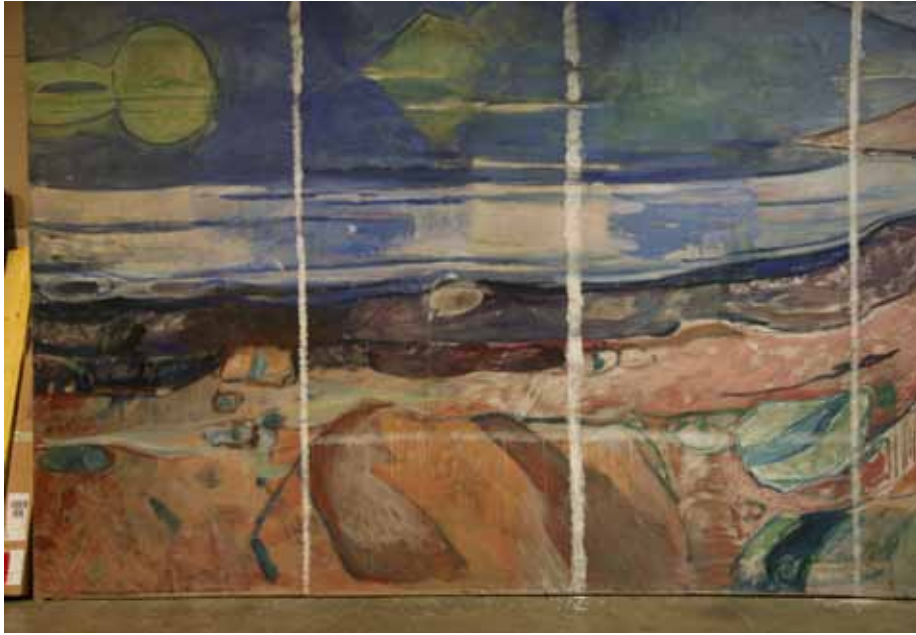
4 Detail of *Alma Mater* showing stripes of local facing with cyclododecane in areas that correspond with masonite joins. Photographer: Karen Mengshoel, September 2010.

areas of flaking paint was consolidated with 3% sturgeon glue solution in distilled water. Consolidation was performed during cleaning and not prior since this was the most effective due to space and time constraint. The characteristics and condition of the original painting techniques led to the decision to choose cyclododecane as the non-aqueous material for the temporary facing. Two different solutions of cyclododecane was used as a protective facing to sensitive areas on the paintings such as, high impasto, areas with cracked paint and areas above the masonite joins (figure 4)

where there were risks of movement after removal of the framework. For the most part cyclododecane dissolved in white spirits (1:10 cyclododecane to solvent) was preferred because this solution had longer working time and good handling properties. In some of the paintings the solution created haloes<sup>34</sup> in the absorbent paint and ground. This meant that the facing material had penetrated deeper into the painting structure than expected and would therefore take longer to sublimate. In these areas cyclododecane was applied as a melt instead of as a solution.

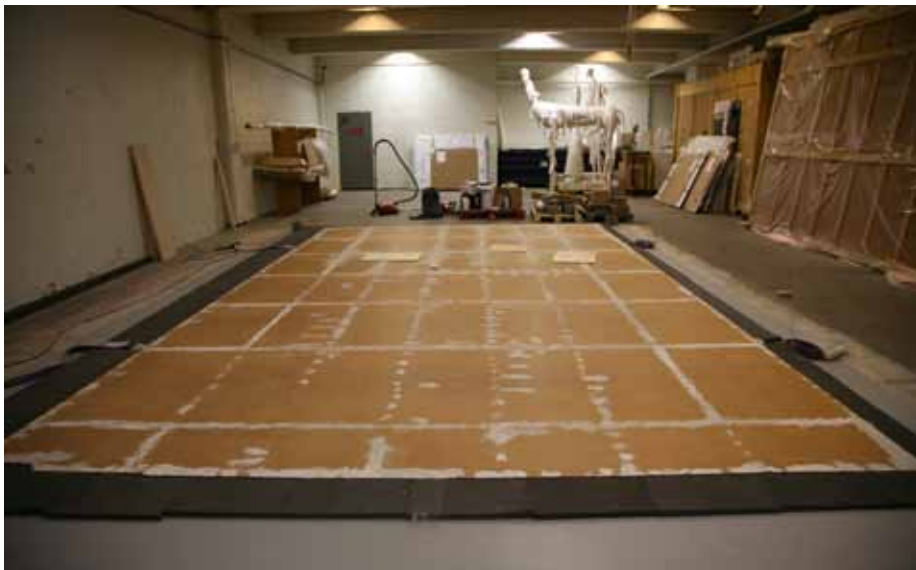
5 Reverse side of the masonite attached to *The Sun* with holes and gaps leveled with commercial fillers. Photographer: Karen Mengshoel, June 2010.

After removal of the framework and the nails, the masonite's surface had to be prepared prior to the attachment of the new and additional support. It was imperative that the masonite's surface was as level as possible due to the limited gap filling properties of the chosen adhesive. Raised areas were sheared off with a sharp scalpel or knife and any small indentation were filled with commercial fillers.<sup>36</sup> Larger holes in the masonite, like screw holes from previous attachment to the niches, were taped with masking tape since these holes were too large to be filled. The whole reverse surface was then sanded down with a fine sandpaper to remove any excess filler as well to ensure a good grip for the gluing (figure 5). This process of leveling and sanding was repeated several times until the correct level surface was acquired. Lastly, the masonite was vacuumed and cleaned with isopropanol.

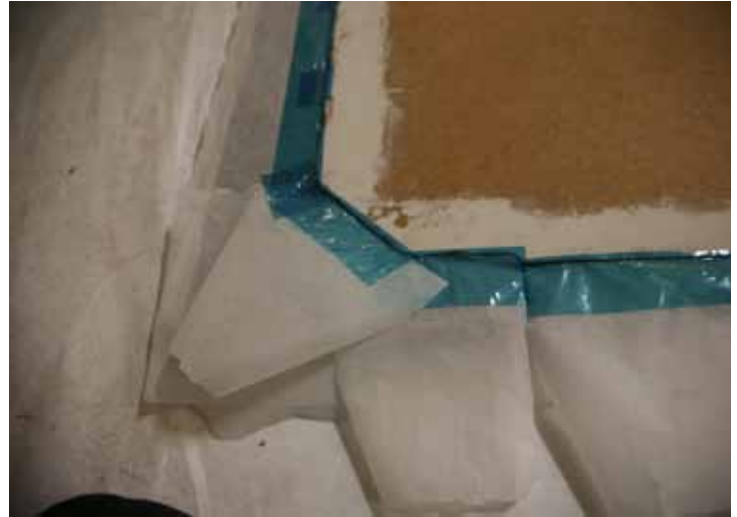
6 Detail of the reverse side of *Alma Mater* showing the masking with a silicone release tape and paper to avoid spillage of the marouflage adhesive on to the surface of the painting. Photographer: Karen Mengshoel, September 2010.

The edges of the painting had to be prepared so as to safeguard that no adhesive would spill over the edge and adhere to the canvas (which in some areas was larger than the masonite) and the painted surface itself. A silicone adhesive release tape<sup>37</sup> was used to mask off the edges, approximately 5 mm in over the masonite, with the rest of the tape adhered to the silicone release paper (figure 6). Any spillage would then run down the silicone paper and not onto the foam which could risk it coming into contact with the paintings surfaces.

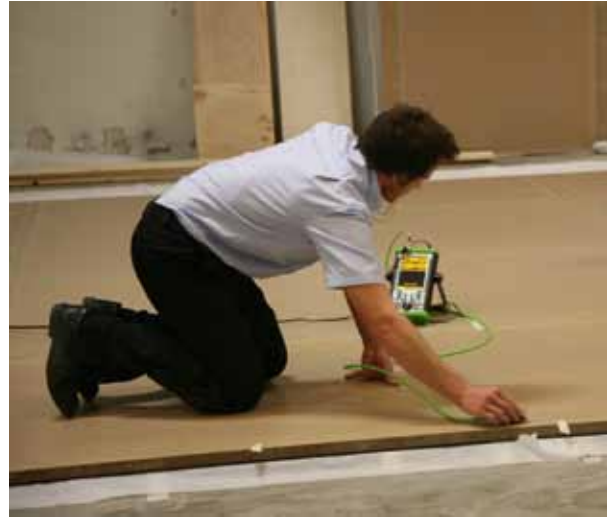
8 The non-destructive testing with Bondascope 3100 on the reverse side of the honeycomb to test for dis-bond between the first and the second marouflage panel. Photographer: Karen Mengshoel, September 2010.

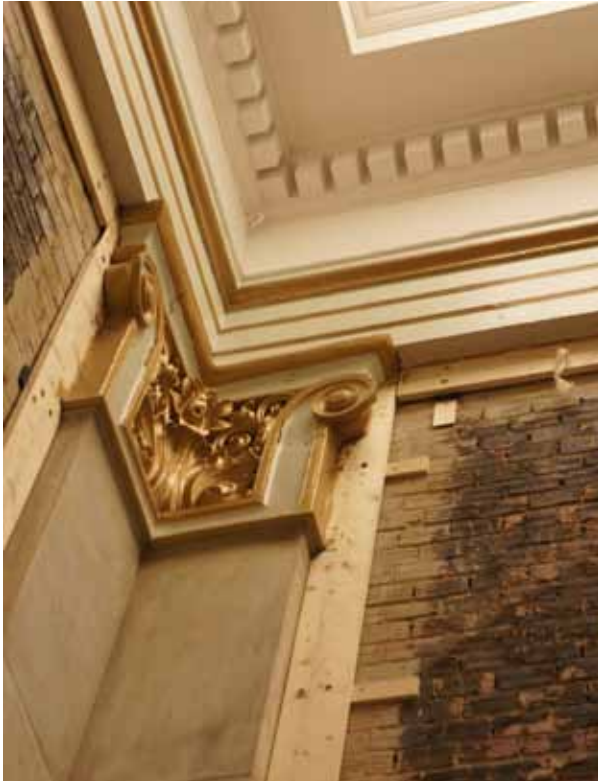
9 Detail of the new wooden frames along the edges of the picture niches for the attachment of the paintings. Photographer: Mirjam Liu, December 2010.

During the building renovation, a wooden framework of Norway spruce (*Picea abies*) (consisting of 148 mm wide and 22 mm thick boards with 100 mm long self-tapping screws<sup>44</sup>) was secured along all edges of the picture niches to provide an even, straight and vertical background basis (figure 9) for the recent re-installation of the paintings.<sup>45</sup> In order to simplify the re-attachment of the Aula paintings, sections of the volute wall capitals on each side of the niches, were converted into detachable sections (figure 10).

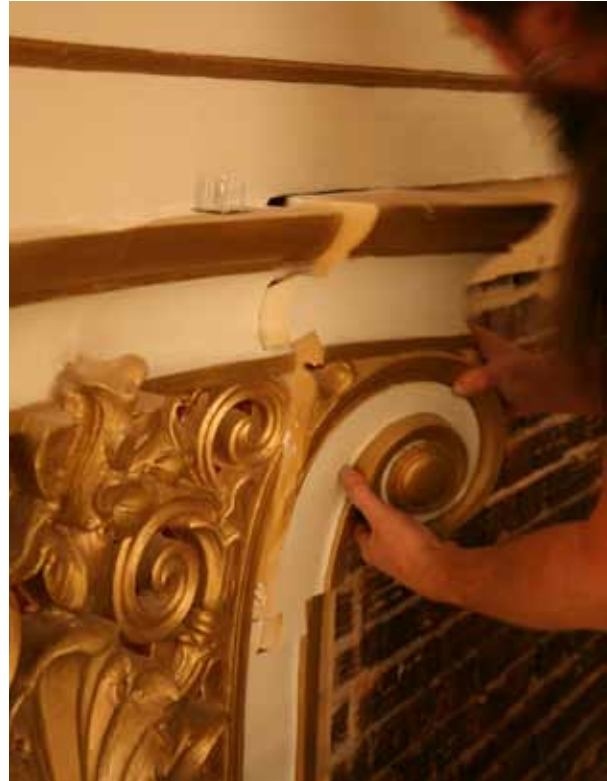
10 Detail of a volute wall capital made detachable to simplify new and future detachment and re-attachment of the paintings. Photographer: Mirjam Liu, February 2011.

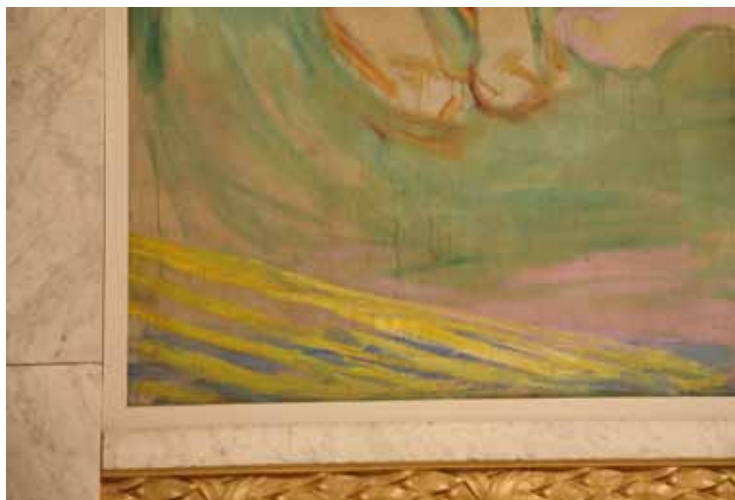
11 Detail of the new picture frame. Photographer: Karen Mengshoel, April 2011.

The new framing system consist of c. 300 m of seamless glass fibre picture frames (4 cm wide and 3 mm thick) (figure 11) attached with Velcro<sup>52</sup> pre-fixed to the aluminium frames.<sup>53</sup> They hide the gaps between the paintings and their surrounding marble as well as the stucco work, The frames also provide protection for long and narrow stripes of pristine areas of Munch's colours having minimal contact with the room's atmosphere. These areas will give valuable information for future examination on how the atmosphere may change Munch's materials. In the narrow areas where these frames encroached slightly over Munch's paint, a protective woolen felt tape was inserted. Prior to their attachment, the picture frames were painted with a matt, light grey colour in keeping with the main colours of the marble surrounds.<sup>54</sup> The choice of Velcro allowed for their easy removal and avoided introducing screws or nails.

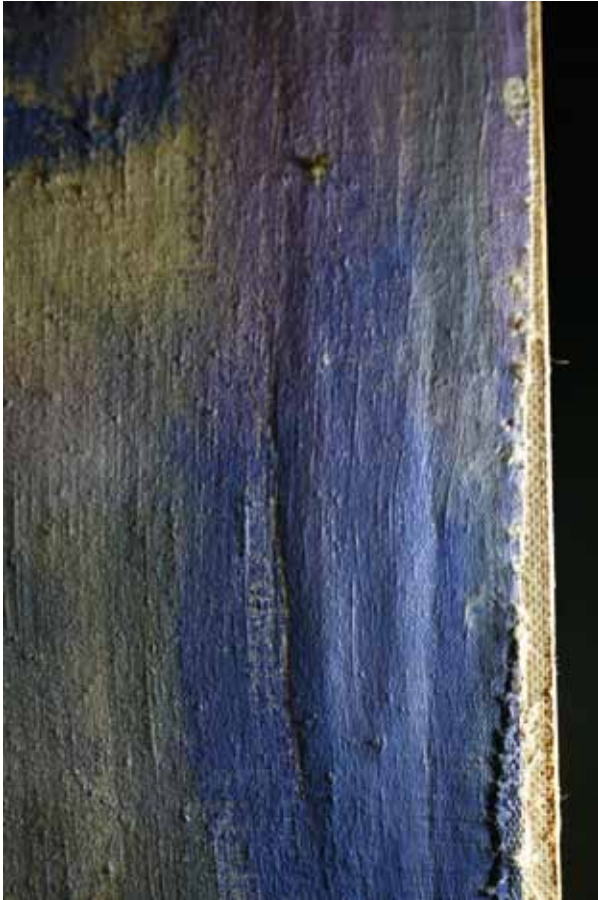
At present, the attachment between the masonite and the original canvas is generally good. Visual surface examinations in raking light combined with fingertip touches (causing a diverging, hollow sound) have revealed that all the paintings suffer from small and local de-laminations between their fabrics and the wood-fibre boards (figure 12).<sup>65</sup> Above some of these voids the paint had started to flake, at worst with minor losses. It is clear that movements in the wooden framework had been responsible for some of these detachments, but far from all since there are several which are located elsewhere and in a random manner. Blind cleavages in the support structure can cause continuing damages on a microscopic level, such as micro-cracks in the paint layers that will lead to further cracking and finally more flaking paint. If the voids also are expanding in scale, it is essential to know the reasons and at what rate. The randomly located de-laminations between the original support and the masonite can have different causes, but there are no visual or tactile evidences of their age. They may have occurred at once during the mounting campaign in 1946, for instance due to uneven applications of rye flour adhesive, or because of local shortages of sufficient pressure or heat. Or they can have been formed later on, for instance as a result of climatic changes in the Hall (from c. 8 to 80% RH) followed by changing temperatures (within indoor limits). During the Aula project, none of the observed de-laminations seemed to expand in size and no new ones were detected, but we cannot exclude that such changes might not occur. If they are caused by an on-going decomposition of the paste, this process has to be monitored on site. If the de-laminations will proceed, they also have to be understood better to enable discussions on future treatments and to predict if or when the 65 years old marouflage paste will start to fail in larger areas.

12 Detail in raking light of de-lamination between canvas and masonite.  
Photographer: Mirjam Liu, October 2010.

Possible interventions can be minimal invasive as local regeneration or re-consolidation of the adhesion or maximal as removal of the materials in the two ma-rouflages. Local re-attachment between the canvas and the masonite will be a challenge because of the sensitive and absorbing ground which is easily stained by water and most organic solvents. This approach will demand tests on how to apply suitable and adequate portions of non-staining glue into the de-laminations and from the front of the paintings. Fast evaporating organic solvents might not stain the original materials, but this also requires tests. The adhesive has to be low-viscous to be inserted locally to the voids through the paint layers and canvas threads and with a thin syringe (which inevitably will leave small holes, although invisible for the Aula audience c. 7-3 m below), but its viscosity will also be crucial due to the strong capillary forces in the absorbing ground and canvas.

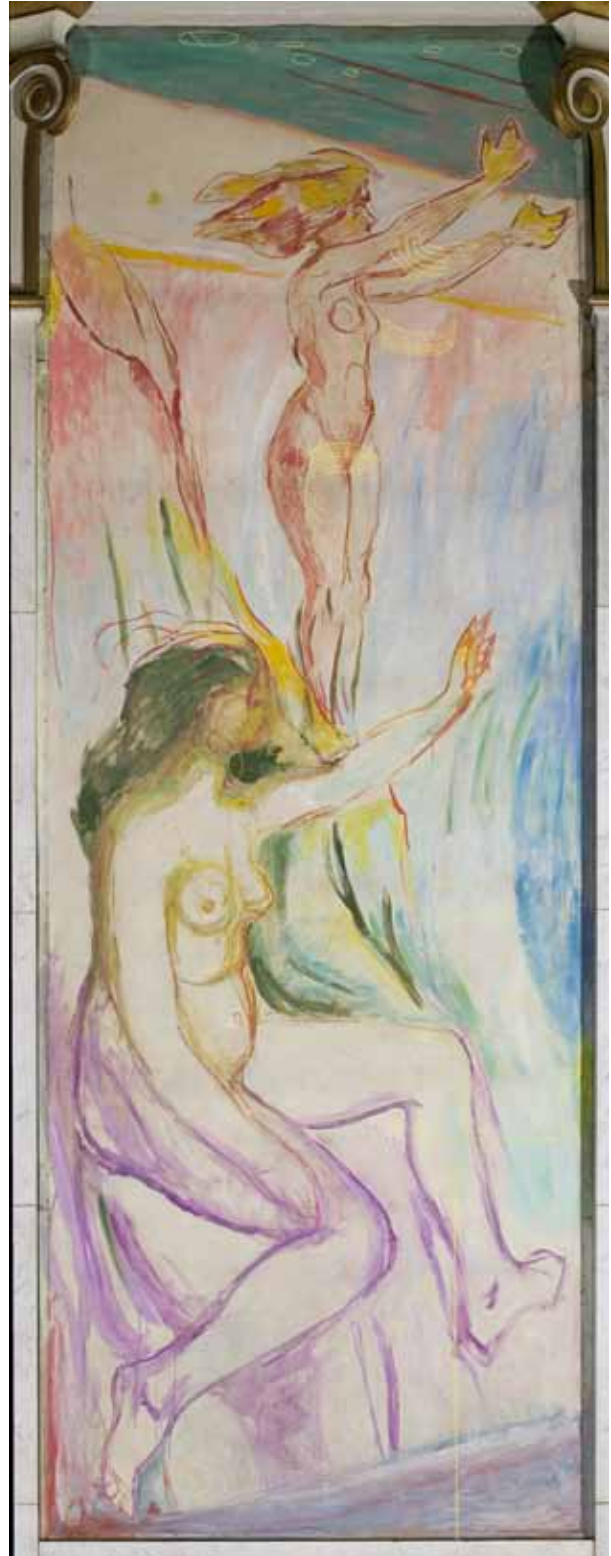
13 Metigo Map of *Women Reaching towards the Light* showing the areas of de-laminations (yellow) between canvas and masonite. Illustration by Mirjam Liu, October 2010.

Future inspections of the de-laminations will also be achieved by new visual examinations under raking light. The visual information provided can be directly compared with the initial Metigo-mapping images.<sup>76</sup> Additional recording techniques for the structural conditions of paintings; either with NMR-Mouse,<sup>77</sup>
